MUST-SEE SOLUTIONS

Intake Manifold and Valve Cover Kit

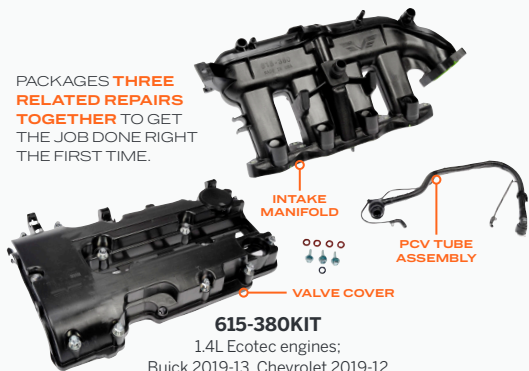
615-380KIT

The valve in the intake manifold often becomes dislodged, causing excessive vacuum that then damages the diaphragm integrated into the valve cover's PCV cap.

A complete repair of all damaged components, with a redesigned, OE FIX manifold to prevent future intake manifold and valve cover failure. It also includes a PCV tube assembly, because this part frequently breaks during removal.

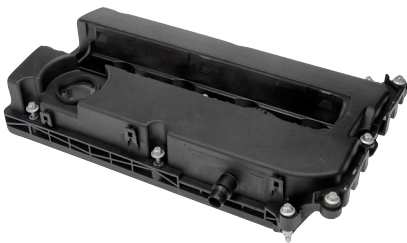
264-920

Engine Valve Cover

Direct replacement valve cover matches the fit and function of the original equipment part that may be damaged or warped

- Made of quality materials to withstand extreme temperatures to resist leaking
- Installation hardware included for a complete repair solution

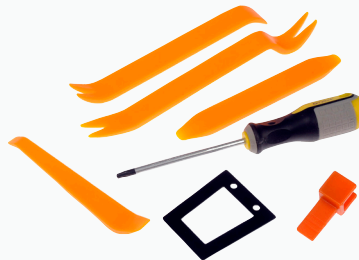
926-288

Sliding Door Handle Repair Kit

The sheet metal fatigues behind the door handles on certain minivans, leaving the handle unsecured without extensive repair to the door panel.

This door handle repair kit allows the damaged door panel to be repaired in place with no cutting or welding to securely restore the handle's function.

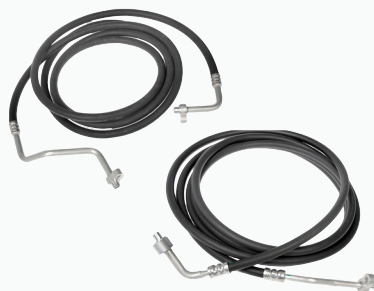
926-999

A/C Hose Assembly

The factory aluminum A/C lines corrode with exposure to the elements, causing the air conditioning system to fail.

These time-saving Dorman OE FIX A/C lines are made of flexible reinforced rubber to simplify installation under the vehicle.

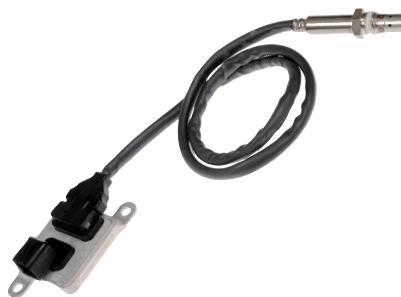
904-421

Nitrogen Oxide (NOx) Sensor

Direct replacement NOx sensor matches the function and performance of the original sensor on specified vehicles

- Original sensor fails due to debris and contamination, resulting in illumination of the check engine light and vehicle going into engine derate

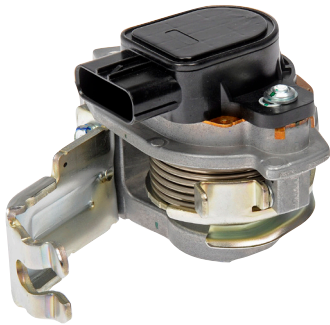
699-199

Accelerator Pedal Sensors

Direct replacement accelerator pedal position sensor matches the fit and performance of a failed original equipment sensor to restore proper vehicle operation

- Plug and play installation - no special tools or programming required to install this sensor

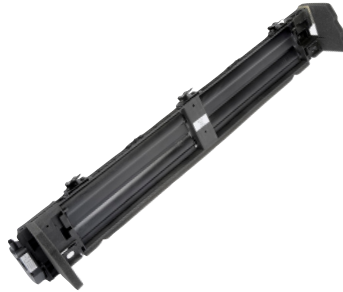
601-332

Radiator Shutter Assemblies

Matches the fit and function of the original equipment shutter to restore function to the vehicle's active grille shutter system

- Plug and play installation - this grille shutter assembly is made with a factory-style electrical connector for a trouble-free installation
- Mounting bracket included for a complete repair solution

- Broken grille shutters or motor failure, illumination of the check engine light or high engine temperatures

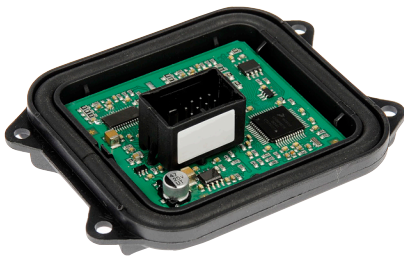
601-318

Adaptive Light Module

Matches the fit and function of the original equipment module to restore proper directional control to an adaptive headlight

- Durable construction features a new housing and seal to prevent damage from moisture intrusion

- Water intrusion in the head light will lead to shorts in the module's circuit board, causing error light to display

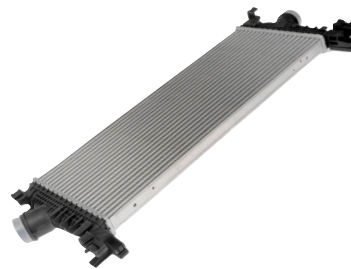
904-963

Intercooler

Direct replacement for an original equipment intercooler that has failed from oil contamination or leaks

- Durable construction is made from corrosion-resistant aluminum
- Has undergone dimensional, corrosion and flow testing to ensure proper fit and performance

- Clogged or corroded tube causes engine power loss or increased fuel consumption

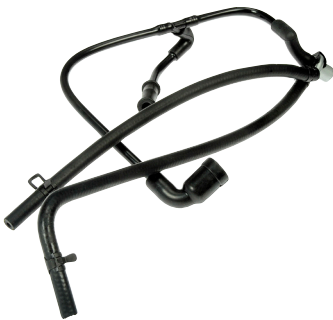
46831

PCV Valve Tube

Made from quality materials to resist cracking and brittleness, this PCV hose replaces a worn or leaking original equipment hose

- Designed to withstand exposure to extreme temperatures and oil vapors

- Breakage from age, wear and tear or removal leads to rough idle, oil consumption and illumination of the check engine light

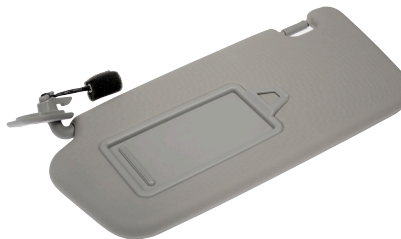
74207

Sun Visor

- Matches the original sun visor in style, color and texture to blend seamlessly with overall interior

- Sagging, broken detent mechanism or separating at seams
